# CEJN Alert Ring

*- Visual safeguards to ensure proper connection*

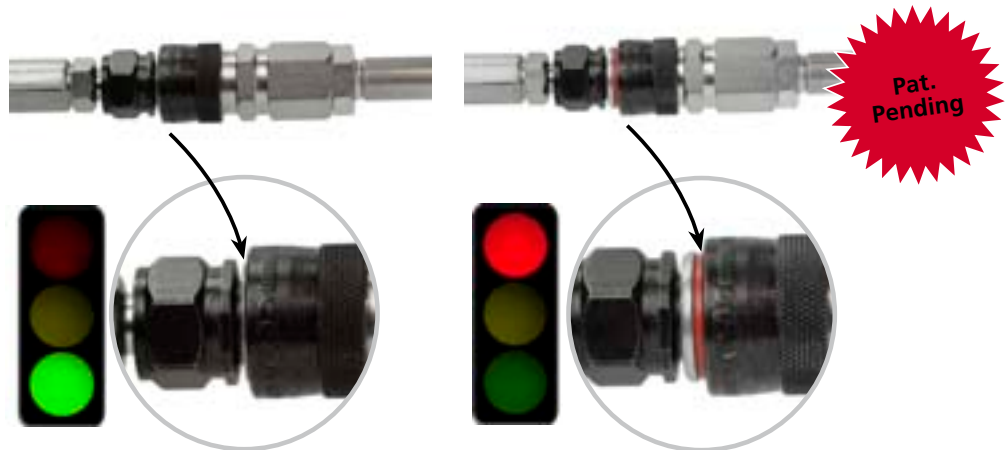
In rough and stressful work environments there is always a risk that the coupling may not be completely connected, CEJN alert ring is a visual safeguard to ensure proper connection. If the red ring is visible, the coupling isn't connected.
